The Reality of Palmyra Before and After the Fall of the Assad Regime

Prepared by: Hasan Ali, Isber Sabrine, Mohammed Fares

On December 8, 2024, Syria achieved freedom with the fall of the Assad regime, which had both positive and negative impacts on the future of archaeological sites, particularly Palmyra. On the negative side, the resulting security vacuum increased the risk of looting and vandalism, necessitating intensified efforts by the current administration to protect the archaeological site. Conversely, the change in leadership marked the end of a corrupt era, potentially facilitating the protection, reconstruction, and restoration of Palmyra's heritage and its reestablishment as a tourist destination in Syria. During a field visit by a member of the Palmyrene Voices initiative, "Mohammed Fares," on January 5, 2025, initial observations were made to assess the current state of the site:

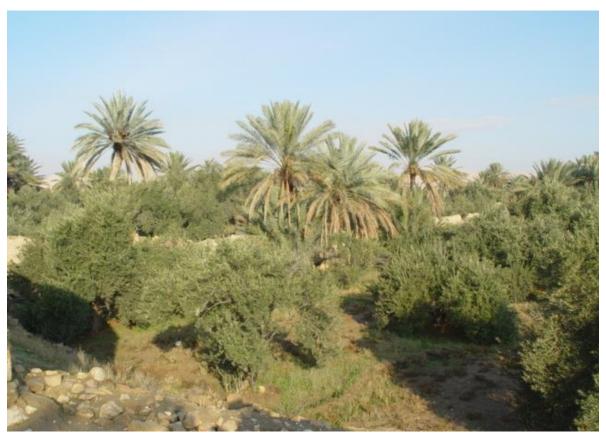
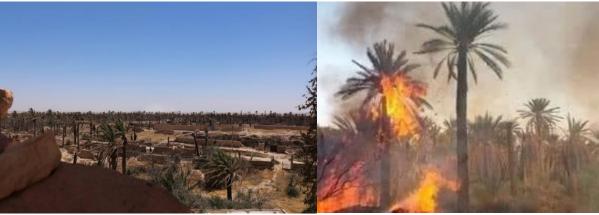
Figure 4: Scenes of Palmyra oasis before, after the drought and during the fire. Photo by Hasan Ali 2008, Mohamed Ramadan 2020

In addition to the burned section, the remaining trees in parts of the oasis that no longer receive spring water have dried up and turned into deadwood. Currently, some orchard owners who have returned from displacement are using simple means to save what remains of their palm and olive trees. (Figure 4)

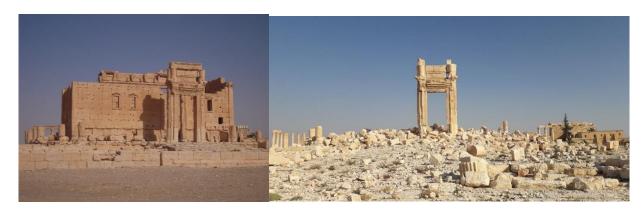
Figure 8: Photos of the sanctuary of the temple of Bel before and after the bombing. Photo by Hasan Ali 2011, Mohammed Fares 2025

The sanctuary of the Temple of Bel was destroyed by ISIS on August 30, 2015, rëducing it and the surrounding colonnade columns to rubble. Only the entrance

supports to the cella remain, while the temple's outer walls are relatively intact, albeit with some damage to their columns, stones, and decorative elements. ¹⁷ In 2016, the Russian Academy of Sciences attempted to create a digital 3D model of the temple as a preliminary step toward its future reconstruction(Figure 8). ¹⁸

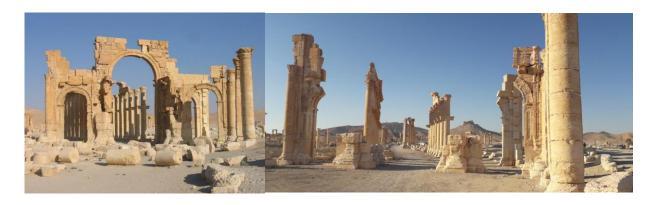
Figure 9: Images of the triumphal arch before and after the bombing. Photo by Hasan Ali 2011, Mohamed Fares 2025

A narrative circulated among local residents on October 4, claiming that ISIS militants had blown up the Arch of Triumph and three columns along the Grand Colonnade connecting the Arch to the Tetrapylon. ¹⁹ However, a field inspection of the fallen stone pieces from the Arch does not indicate an explosion. It is more likely that the stones fell due to an airstrike nearby.

Additionally, sorting and numbering of the fallen pieces from the Arch of Triumph was observed, likely conducted by Russian entities in preparation for restoration efforts. Meanwhile, illegal excavation activities were noted along the Grand Colonnade, which were not present before 2015 (Figures 9, 10).

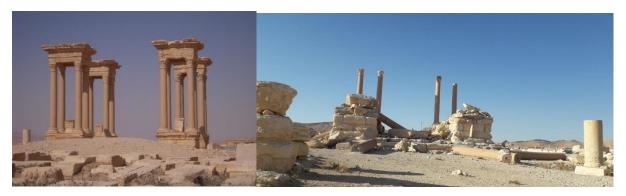
Field inspections of the four structures, known as the Tetrapylon, revealed that they were subjected to explosions, reducing their columns to a pile of rubble and scattered stone fragments. There are no indications of any documentation or numbering of the stones (Figure No. 11).

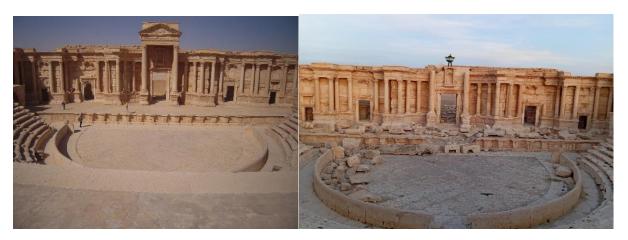
Figure 12: Images from the Palmyra theater before and after the bombing of the façade of the theater. Photo by Hassan Ali 2011, Zaher Al-Saleem 2024

On July 3, 2015, ISIS carried out a mass execution inside Palmyra's archaeological theatre, claiming that the victims were members of Assad's forces. Field inspections of the Theater revealed a collapse in its façade (the upper section of the orchestra). The large fallen stone blocks do not indicate the use of TNT, which ISIS commonly used to destroy Palmyra's landmarks. Instead, it is likely that the damage resulted from a missile strike. Joint Syrian-Russian efforts were made to restore the façade of Palmyra's Theater. A digital 3D model of the Theater was created, and sorting and numbering of the fallen stones were conducted in preparation for restoration. ²⁰ (Figure 12)

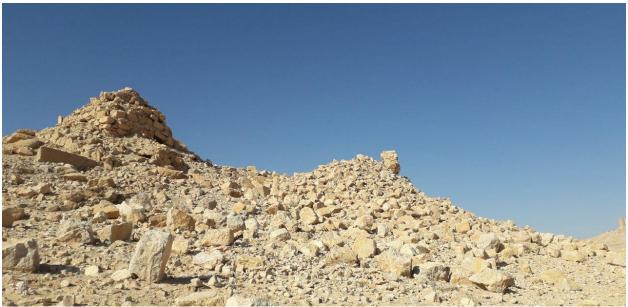
Figure 14: Photos from southwestern burials before and after the bombing. Photo by Hasan Ali 2007, Mohamed Fares 2025, Mohamed Fares 2025

According to media reports and the local researcher Hassan Ali, who observed from the roof of his house, ISIS militants detonated numerous tombs in August 2015, particularly the tower tombs. Approximately ten tower tombs were destroyed, including the Tomb of Elabel and the Tomb of Atenatan, the latter being the oldest tower tomb dating back to 9 BCE. ²²-²¹ Additionally, several house and underground tombs were also blown up. Field inspections revealed that these tombs have mostly been reduced to piles of rubble, except for a few that remain in relatively good condition and were not subjected to explosions. (Figure 14)

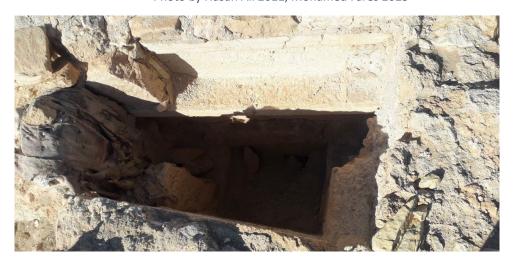
Figure 16: Photos of a secret excavation near the northern walls from the inside, photographed by Muhammad Fares 2025

In 2017, a Russian base was established near the camel racing track in the area of the northern tombs. This involved levelling and clearing large areas to construct a military base and a helicopter landing pad, as well as fortifications for military points around the base. Additionally, the area was cleared to create earthen berms on both sides of the supply road connecting the base within the archaeological zone, linking all military units together. Currently, these sites have been vacated, and there is no military or civilian presence in the area. However, clandestine excavation activities have been observed inside the northern walls. (Figures No. 15, 16)

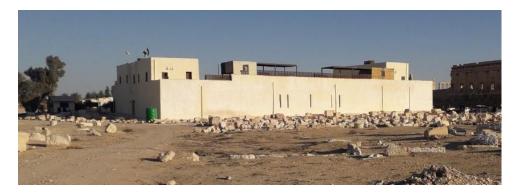
Figure 17: A picture of the Museum of Folk Traditions in Palmyra at the present time. Photo by Mohamed Fares 2025

The Museum of Popular Traditions is currently closed, but the building appears to be in good condition from the outside. (Figure No. 17)
